# **DISTILLATION SYSTEMS**

## **TROUBLESHOOTING AND UPGRADATION**

**By N. M. Madhekar**

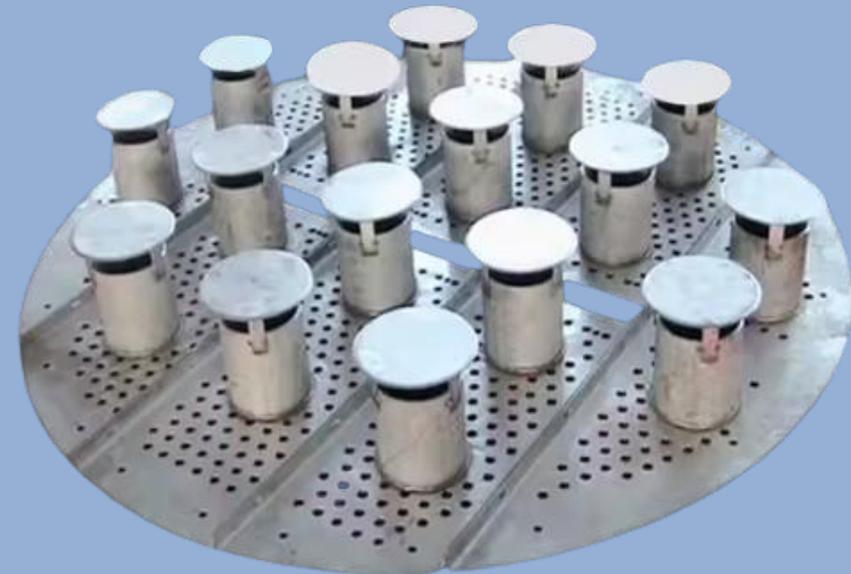
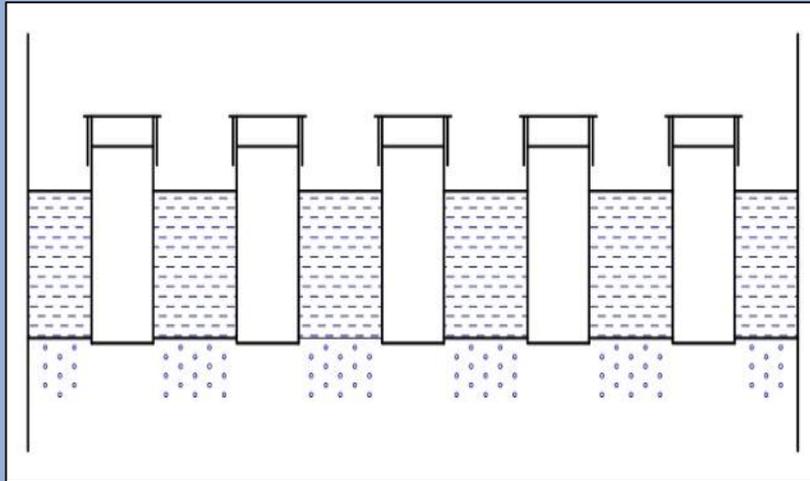
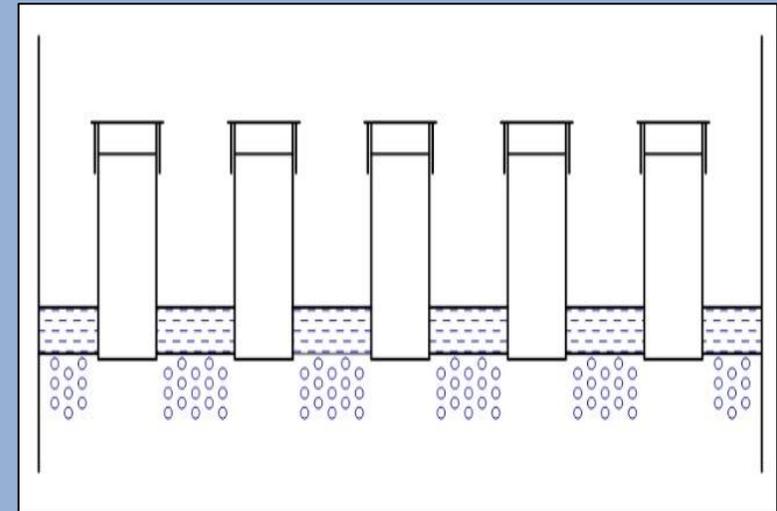
## Case 1: Holdup

A large diameter packed column, with six distributors, was being used to separate close-boiling isomers. The column took very long to stabilize and did not give product of required quality.

Diameter of liquid distribution holes was too small. Therefore, liquid level (hence, the holdup) on each distributor increased. Total holdup became so high that almost all the low-boiler accumulated in the holdup itself, without coming out as distillate.

Smaller holes  $\rightarrow$  lower discharge rate  $\rightarrow$   
higher liquid level  $\rightarrow$  higher holdup

Larger holes  $\rightarrow$  higher discharge rate  $\rightarrow$   
lower liquid level  $\rightarrow$  lower holdup

Solution Diameter of distributor holes was increased.

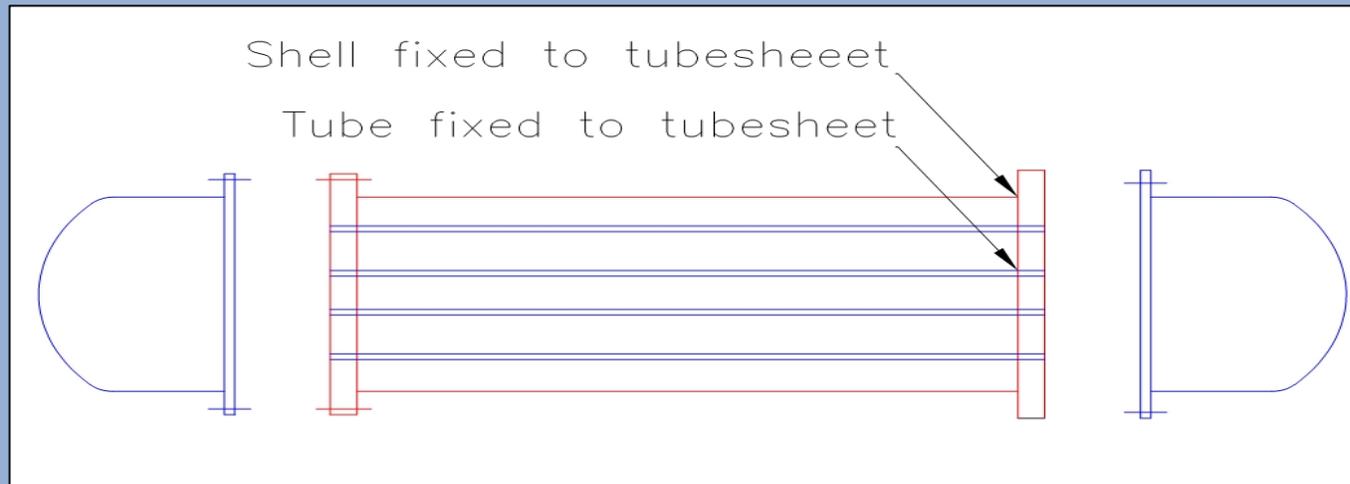
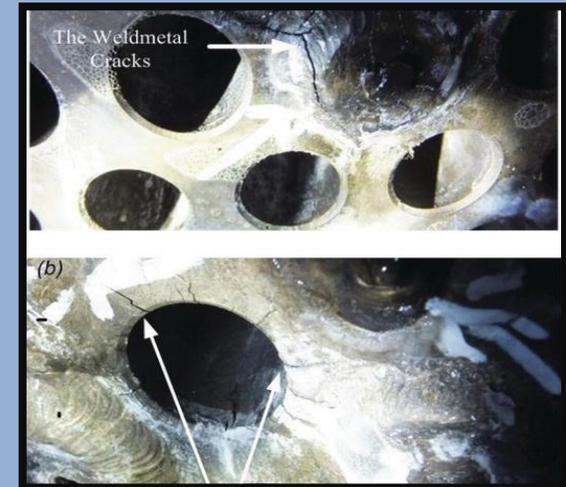
**Case-2** Tube to tubesheet joints in a shell-and-tube condenser were getting damaged.

**Diagnosis** Differential thermal expansion was creating stresses that damaged the joints.

- Shell and tubes are both fixed to the two tube sheets.
- Shell is hotter so it expands more. Tubes are cooler, and expand less.
- Difference in the expansions of shell and tubes create thermal stress.

**Solution** The fixed tubesheet condenser was replaced by U-tube bundle condenser.

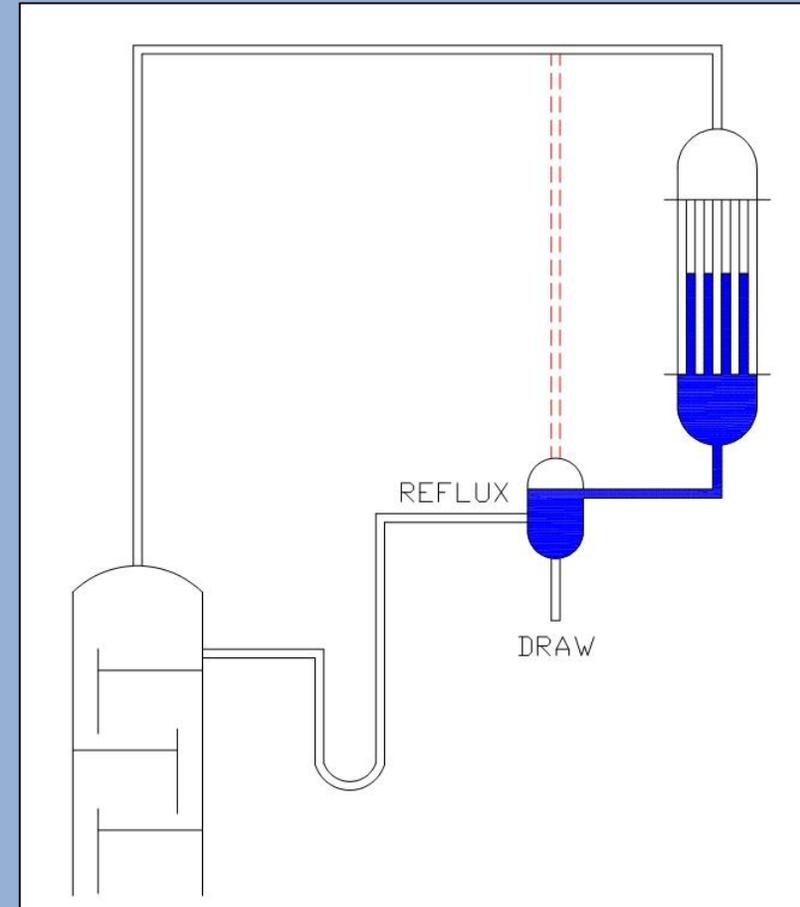
**Case-3** Reflux to a column was flowing in sudden spurts. Distillate purity was not acceptable, even though separation was technically very easy.

- The condenser was not vented. When vapour condensed, a partial vacuum was generated in the condenser. This did not allow condensate to flow to column. Instead, it backed up into the reflux drum as well as condenser. After it reached a certain level, hydrostatic head overcame the pressure differential, and reflux flowed to the column.
- Because reflux was not smooth it was not possible to obtain required distillate concentration.

**Solution** Pressure equalisation line was provided to the reflux pot.

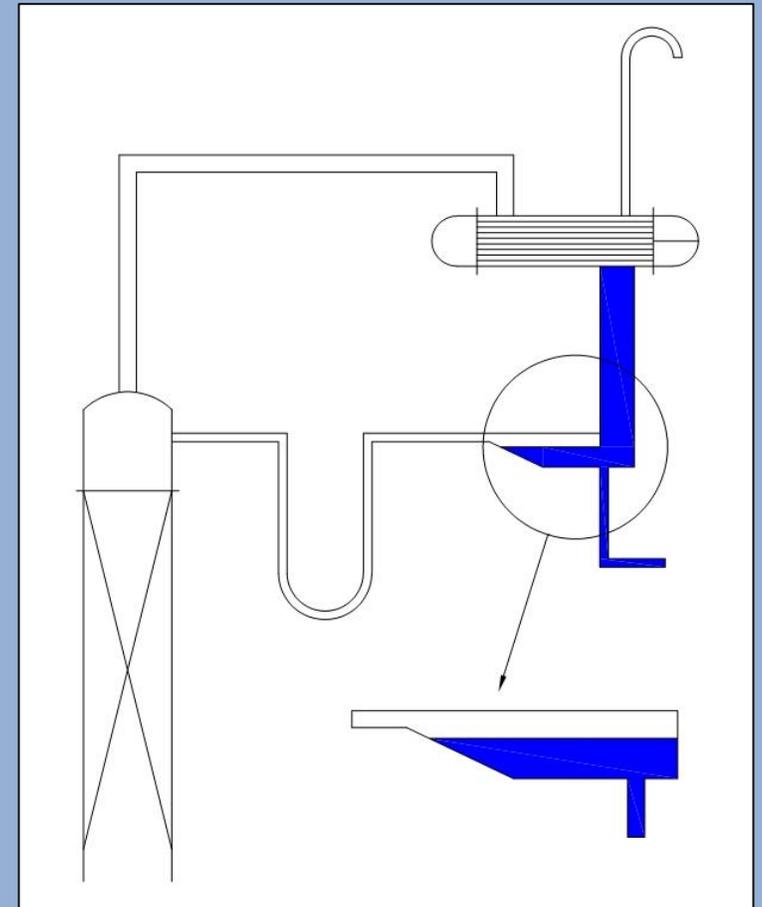
**Case-4** A distillation column was working satisfactorily under normal design conditions. But, when capacity was reduced to 30% of design, reflux stopped and distillate purity became unacceptable.

- Nozzle diameters of condenser and column reflux did not match, and an eccentric reducer had been used. The draw line was tapped from lower part of pipe, while the upper part continued to reflux.
- When flows were turned down, condensate flowed down the lower (draw) pipe, while upper (reflux) side became empty, which affected distillate purity.

**Solution** Size of column reflux, condenser outlet and connecting piping were made equal and eccentric reducer eliminated.

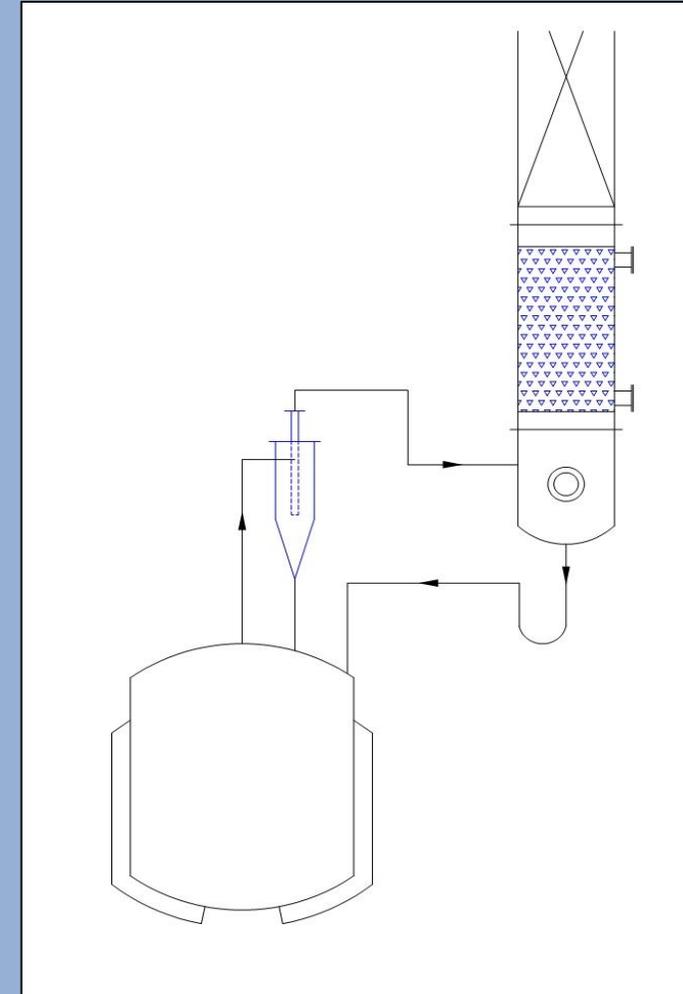
**Case-5** In a batch distillation, bottom section of the column was getting corroded frequently. Removing and replacing damaged structured packings was a tedious process.

Vapour from still was entraining liquid droplets to the column, which contained some inorganic acids.

- The vapour was taken to a cyclone separator that removed much of the entrained liquid.
- Furthermore, a small section of random packings was introduced at column bottom. Damaged random packings could now be removed and replaced in-situ easily.

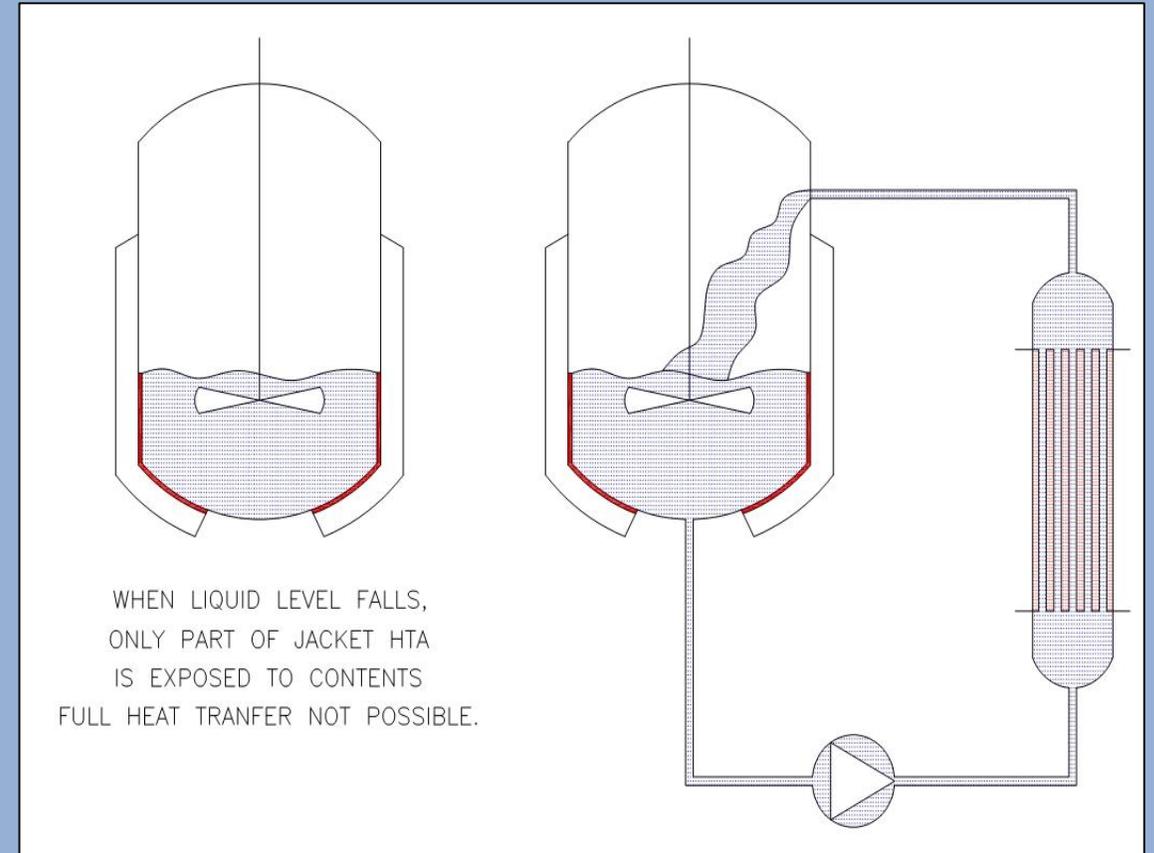
**Case-6** In a batch distillation, vaporisation rate decreased as cycle progressed, resulting in sub-optimal performance.

As level of liquid inside the distillation still decreased, less of jacket area was exposed to heat transfer, resulting in lowered vaporisation rates.

**Solution** An external forced circulation reboiler was provided. The entire area of the reboiler could now be utilised - even when still level had dropped.

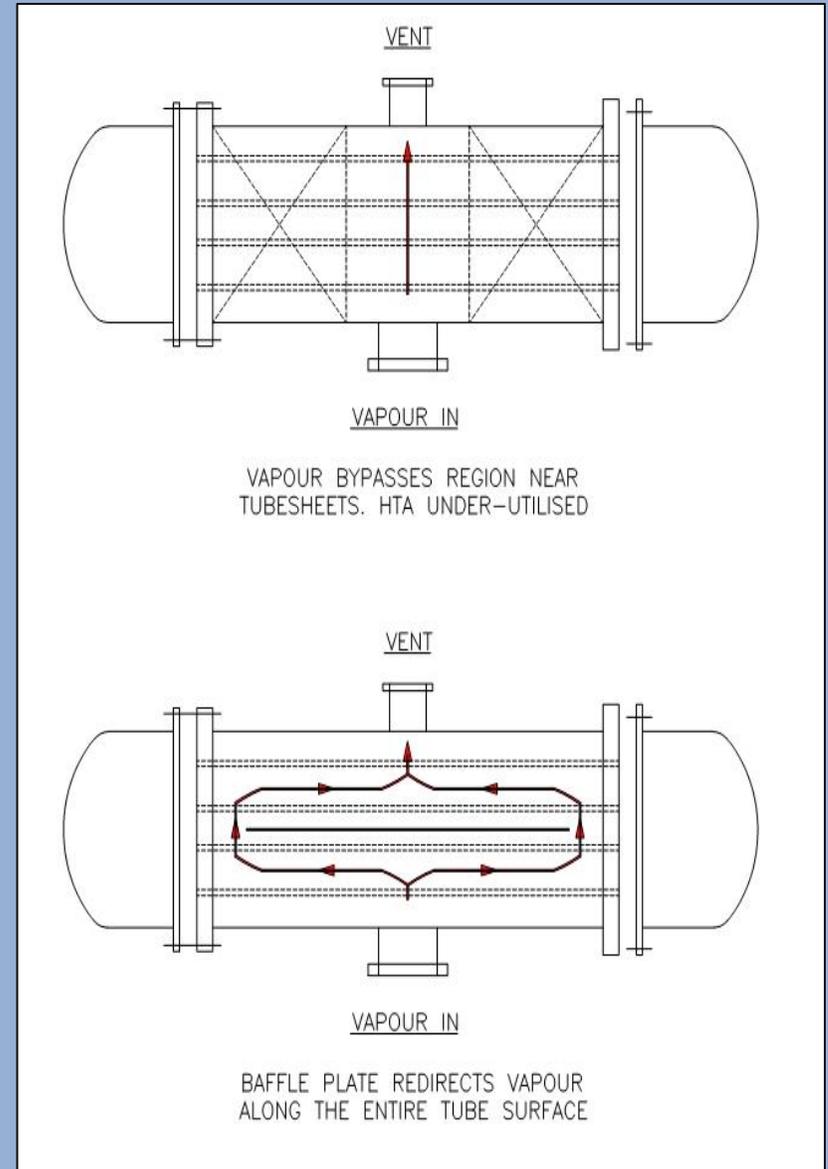
**Case-7** A column-mounted condenser had adequate heat transfer area, but was not performing as per design.

Condenser vent nozzle was located right above its vapour inlet nozzle. Vapour was bypassing most of the heat transfer area, and going directly to vent.

**Solution** The condenser was replaced by another one which had a horizontal baffle. This redirected vapour so that it flowed over the entire heat transfer area.

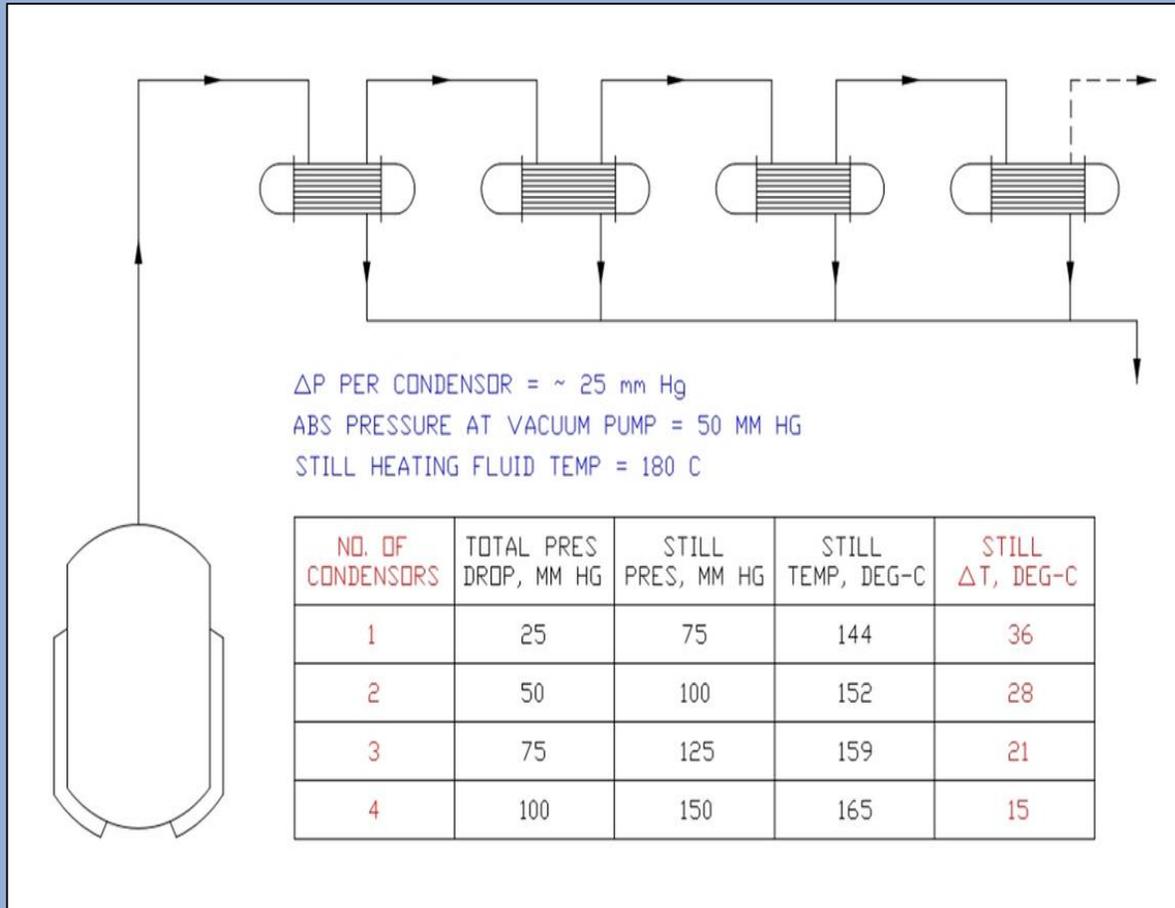
# Case-8

A vacuum distillation system was not giving an adequate rate. When condensers were added in series to increase total heat transfer area, recovery rates actually decreased.

Adding more condensers in series increased overall pressure drop. This increased still pressure and temperature, and thus, reduced  $\Delta T$  and vaporization.

The condensers were replaced by a single condenser with large heat transfer area, which had much lower overall pressure drop.

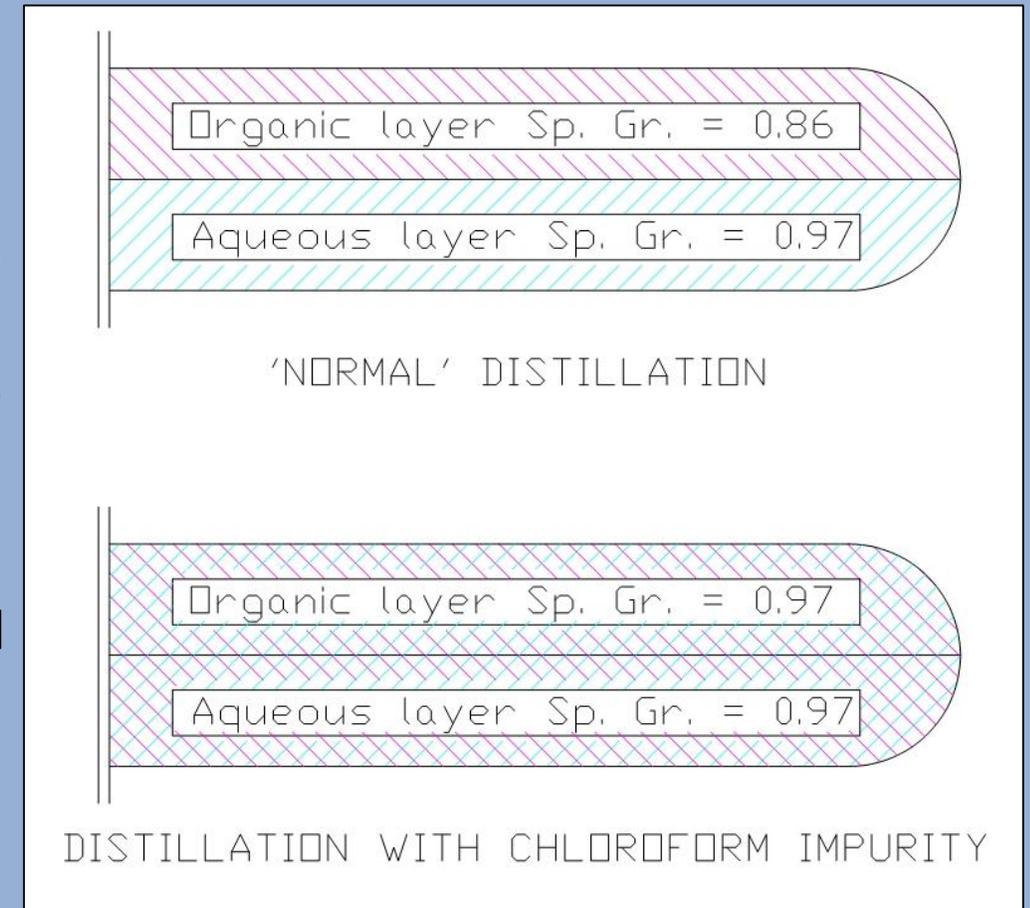
**Case-9** During azeotropic distillation of isopropanol with cyclohexane entrainer, water layer did not form in the phase separator, hence water could not be removed.

- The feed contained small amounts of chloroform, which has a low boiling point and is hydrophobic. So, it rose to column top and accumulated in the organic layer.
- Since density of chloroform is high, overall density of the organic layer increased until it became almost equal to the water layer.
- Consequently, the two layers could not separate, and remained intermixed.

**Solution** The feed was pre-distilled to remove chloroform. Then, chloroform-free feed was distilled with cyclohexane entrainer to remove water.

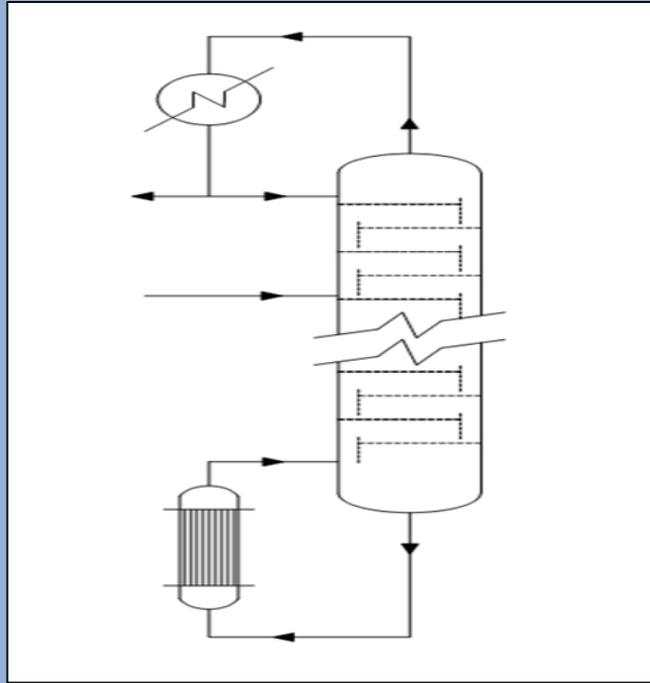
TRAYED COLUMN

**Case-10** A bubble-cap tray column was being used for vacuum distillation of isomers. Vaporisation was inadequate and separation could not be achieved.

**Diagnosis** Bubble-cap tray column had high pressure drop. This resulted in a high bottom pressure, high bottom temperature, and thus lower temperature difference with the reboiler. Consequently, vaporisation was reduced.

- No. of trays: 40
- Pressure drop per tray: 3 mm Hg
- Total pressure drop: 120 mm Hg
- Column top pressure: 50 mm Hg
- Column bottom pressure: 170 mm Hg
- Column bottom temperature: 155 deg-C

**Solution** The tray column was replaced with a structured packing column. Column bottom pressure and temperature decreased, which permitted proper vaporisation.

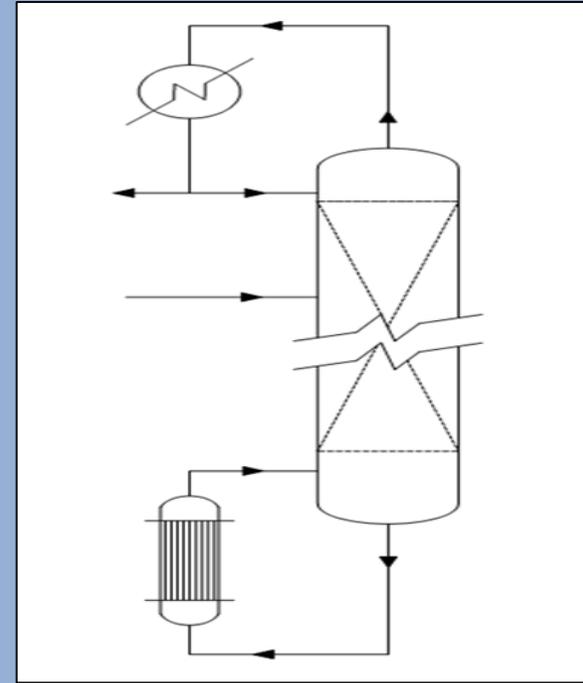
PACKED COLUMN

- Packed height: 8 mts
- Pressure drop per meter: 1 mm Hg
- Total pressure drop: 8 mm Hg
- Column top pressure: 50 mm Hg
- Column bottom pressure: 58 mm Hg
- Column bottom temperature: 122 deg-C
