Troubleshooting Distillation Systems

(by N.M.Madhekar, Partner, Innovative Chemical Technologies LLP, Pune)

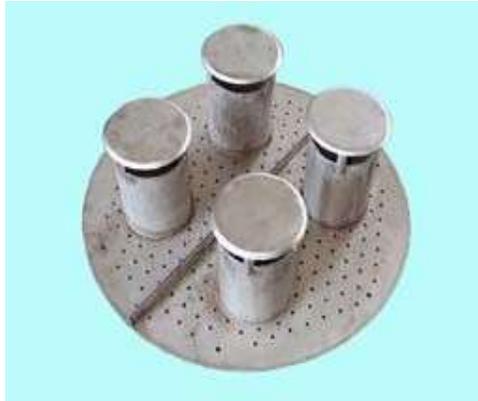
Figure (1): Packed column distributor

It was found that diameter of liquid distribution holes on the distributor was too small. Therefore, liquid level (hence, the holdup) on each distributor was too high. Total holdup became so high, that almost all the low-boiling component accumulated in the holdup itself, without anything coming out as distillate. Furthermore, it took 48 hours of total reflux to stabilise the concentration profile. This problem became worse because of difficulty of separation.

The problem was solved by increasing diameter of distributor holes. This reduced the liquid height on the distributors, thereby reducing holdup as well.

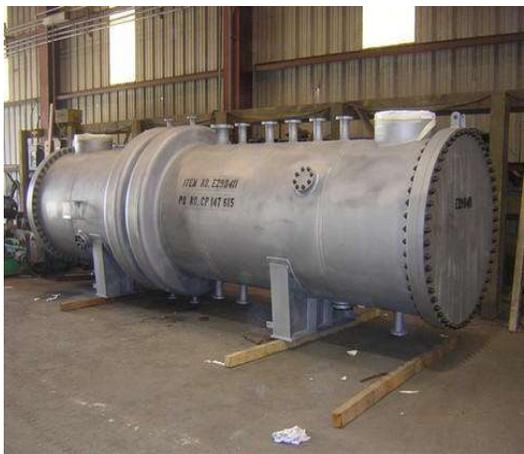
Figure (6): Shell-and-Tube heat exchanger with shell-side bellows.

Another way of eliminating thermal stresses is by using shell-side bellows. These are a sort of cylindrical springs welded on shell side. Thus, any differential expansion between shell and tubes gets absorbed in the bellows, and does not show up as thermal stress.
