# **DISTILLATION SYSTEMS**

## **TROUBLESHOOTING AND UPGRADATION**

**By N. M. Madhekar**

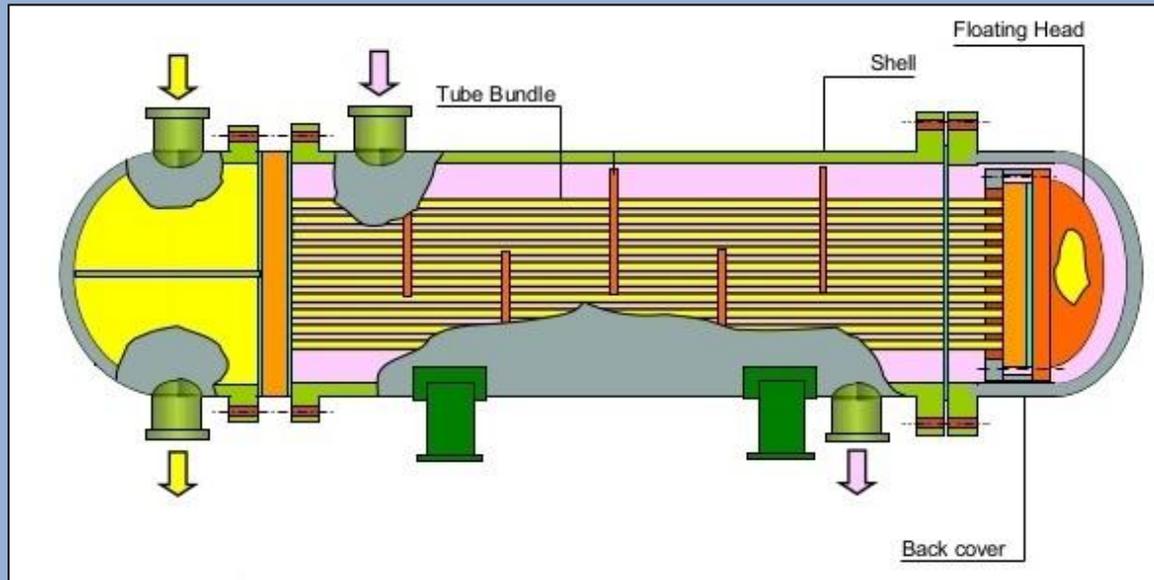
## Floating Head Heat Exchanger

**Diagnosis** Differential thermal expansion was creating stresses that damaged the joints.

**Solution** The fixed tubesheet condenser was replaced by U-tube bundle condenser.
